**Archaeological Evaluation  
Phase 2 Report**

**Former St Hilda's Church  
and Graveyard,  
Middlesbrough, North  
Yorkshire**

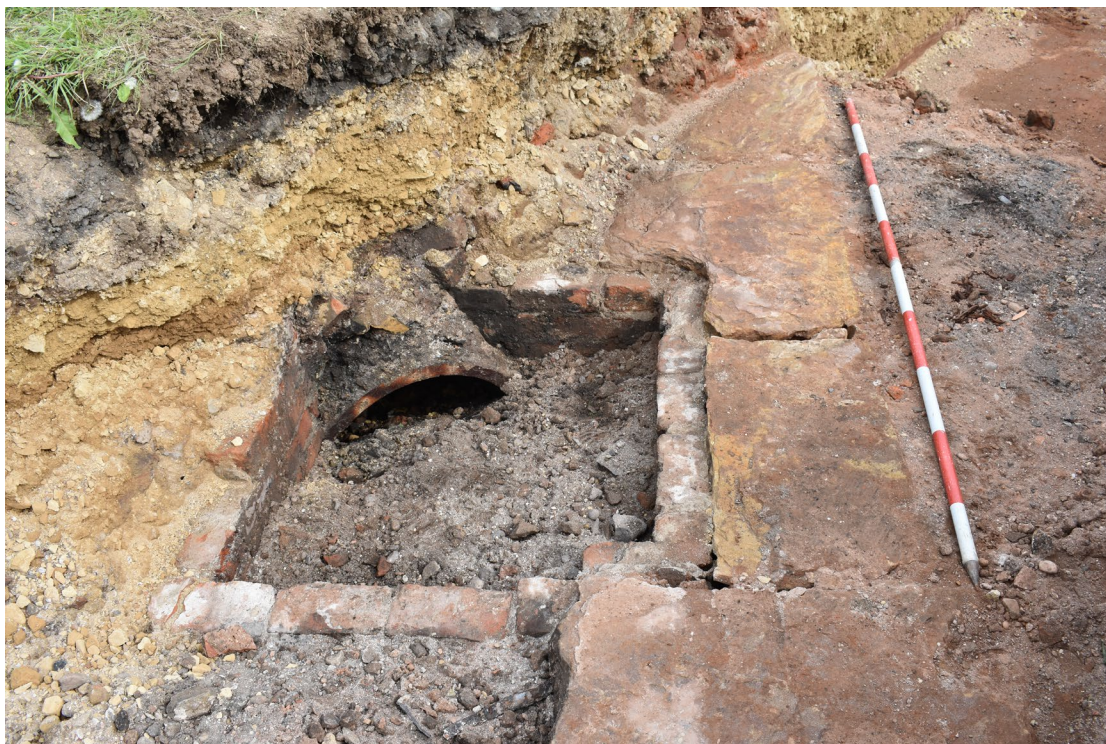
- 7.1.4 Towards the southeast end of Trench 1 a brick wall [112], stone wall foundation [109] and brick drain housing [113] were uncovered (Plate 13). Brick wall [112] was aligned east-west and ran into the southeast facing section of the trench where it likely meets the continuation of wall [108] forming the walls of a building, possibly part of the 19<sup>th</sup> century Methodist chapel. As with wall [108], wall [112] was constructed of bricks measuring 250mm x 110mm x 70mm and a very hard light pinkish-grey sandy lime-based mortar with charcoal flecks. The wall [112] measured 1.3m x 0.24m and was 2 bricks wide with a single course of bricks surviving in the trench at a height of 9.6m AOD, however 5 courses were visible in the southeast facing section. At the eastern

end of the wall [112], on the south face, a U-shaped extension was keyed in, extending the width of the wall to 0.8m, consisting of firebricks with a small recess between them which contained burnt out coke; likely forming part of a boiler room construction.

*Plate 13: Trench 1 looking south-east, scale: vertical 2m*

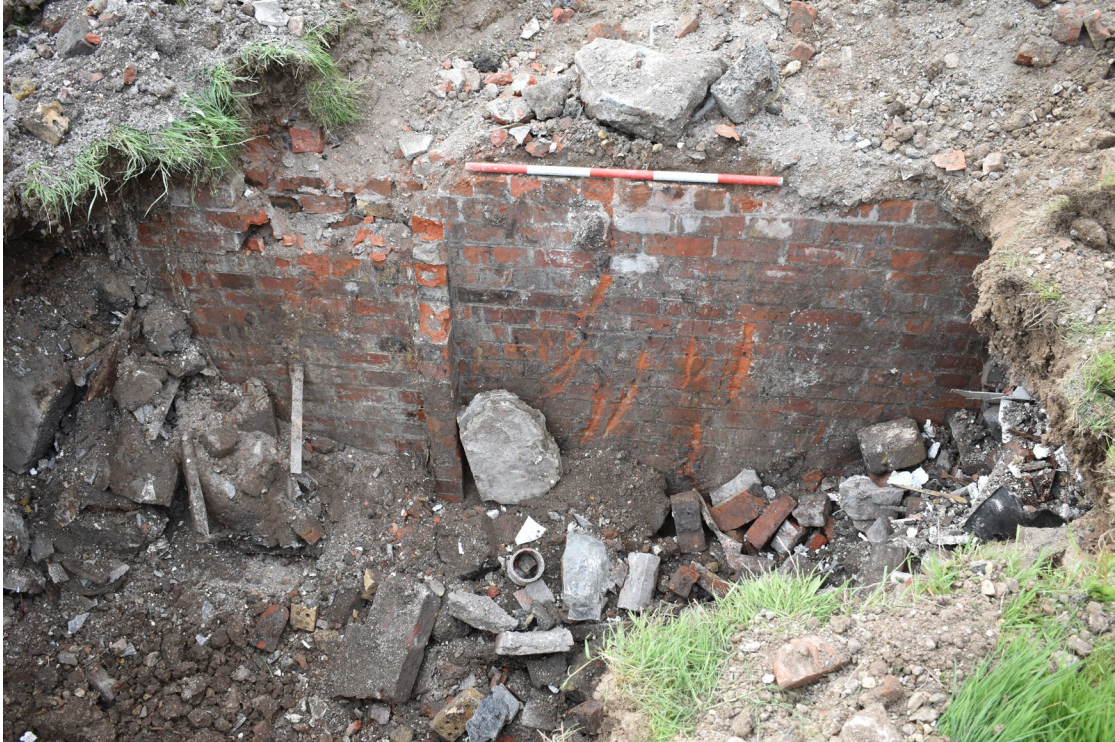
- 7.1.9 At the middle of Trench 1 towards the south-east, a deposit of destruction rubble [102] was observed overlying masonry structures [107], [108], [109], [112] and [113] as well as filling the internal area of the structure [113] (Plate 14). The deposit [102] consisted of loose friable dark brown/black silty sand with inclusions of ash and bricks. The deposit [102] had a maximum thickness of 1.6m covering an area of 11m x 2m and was recorded at a maximum level of 9.79m AOD. This deposit [102] was sealed to the southeast by a layer of chipped stone / crush [110] which also overlaid a modern service drain and was recorded at a thickness of 1m covering an area of 12m x 2m with a maximum height of 9.81m AOD.

*Plate 14: deposit of destruction rubble [102] overlying masonry structures [107], [108], [109], [112] and [113], looking north-west, scale: horizontal 1m*

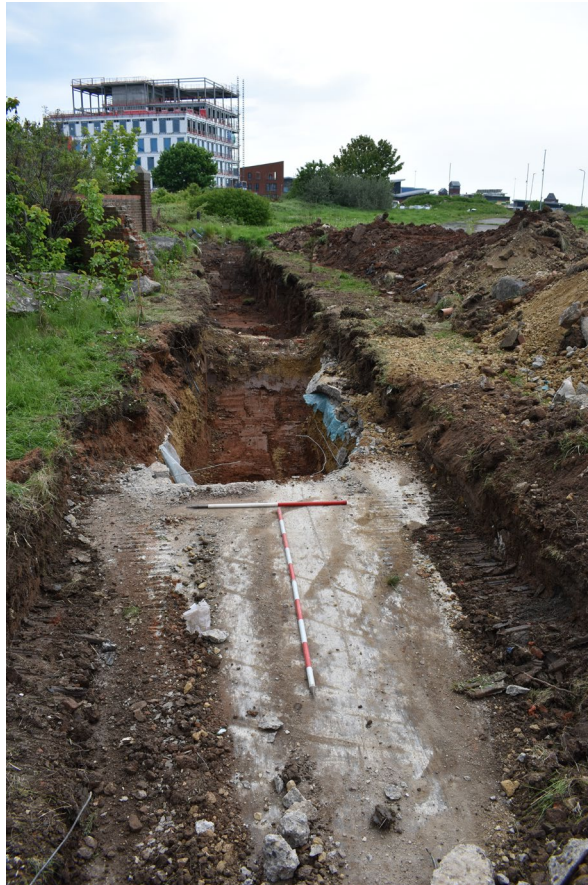
*Plate 15: Trench 2 looking south, scale: horizontal 1m; vertical 2m*

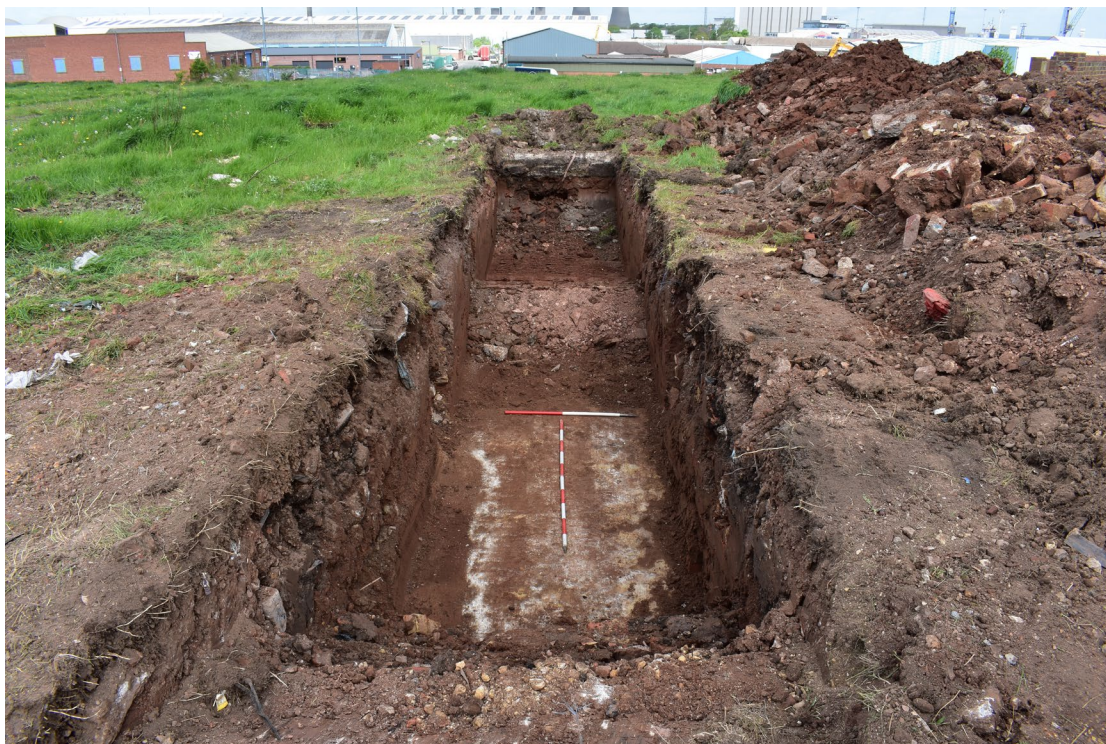
*Plate 16: Trench 3 looking north-west, scale: horizontal 1m; vertical 2m*

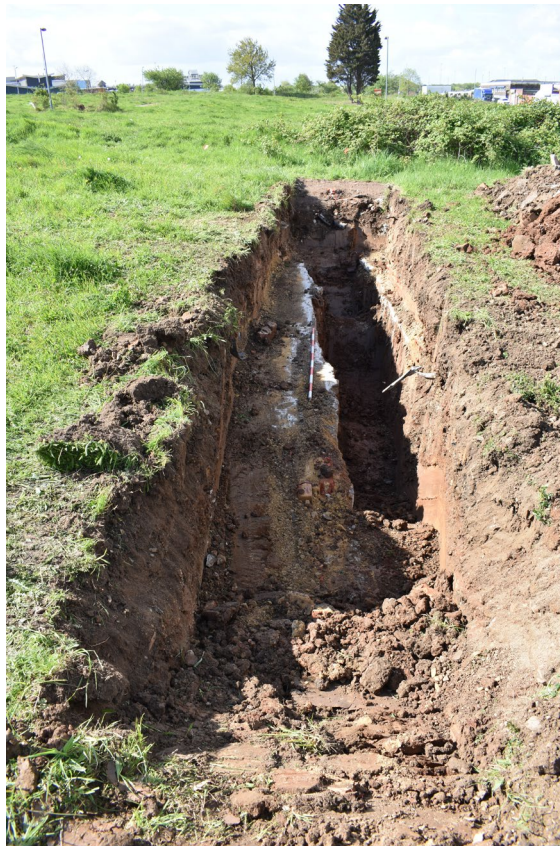
*Plate 17: Trench 4 looking south-west, scale: vertical 2m*

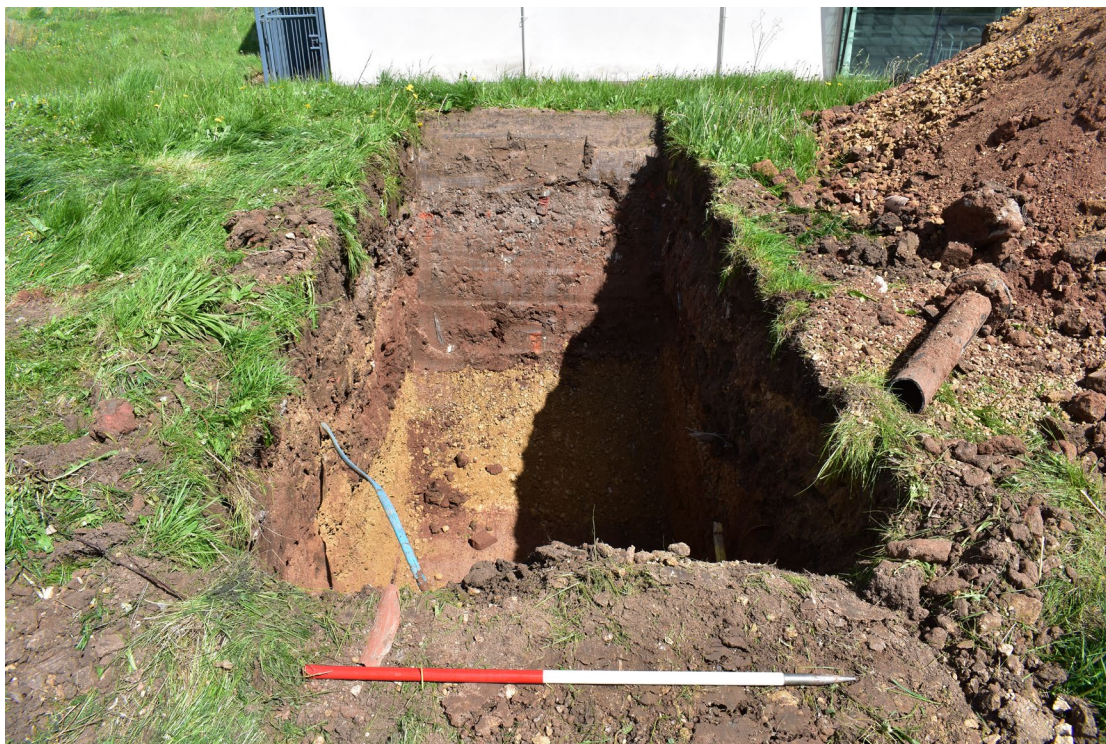
*Plate 18: Trench 5 looking north-east, scale: horizontal 1m*

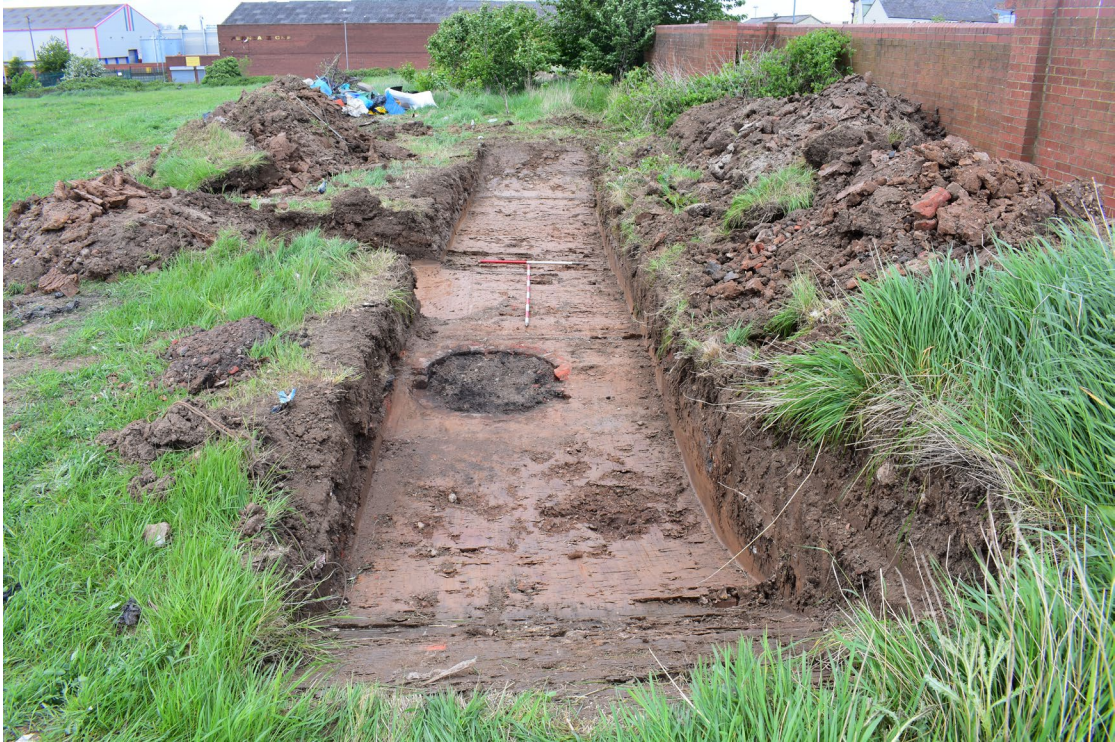
*Plate 19: Trench 6 looking north-east, scale: horizontal 1m, vertical 2m*

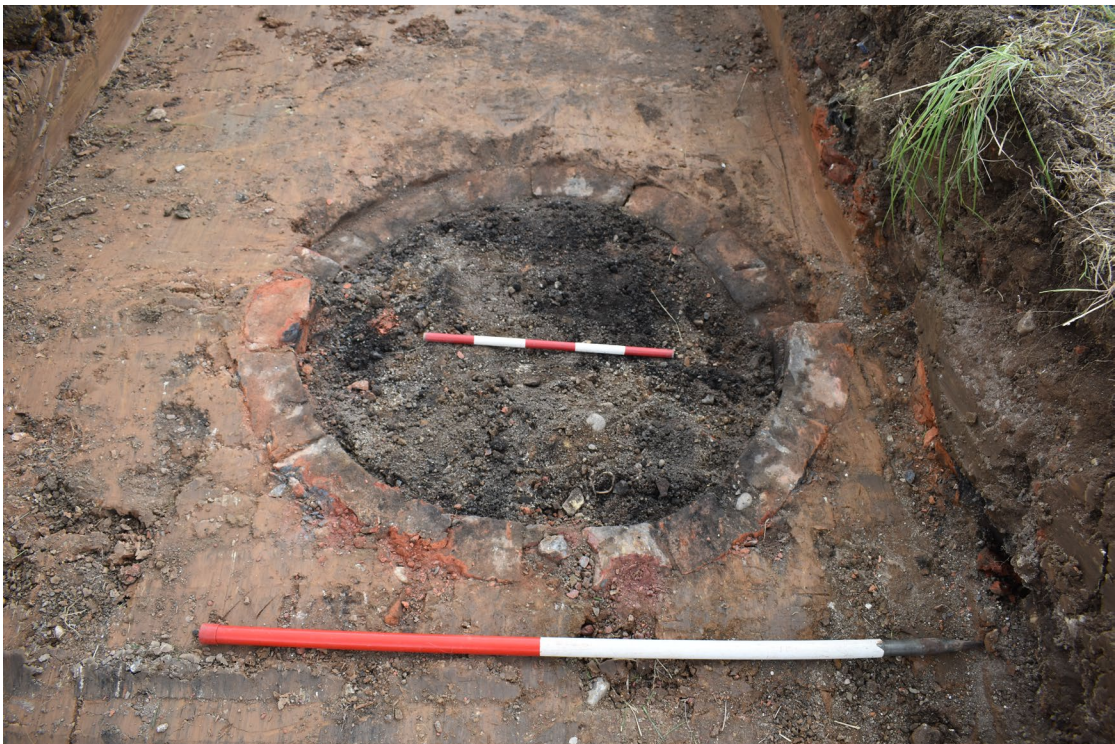
*Plate 20: Well [604] looking south-west, scale: horizontal 0.50m and 1m*

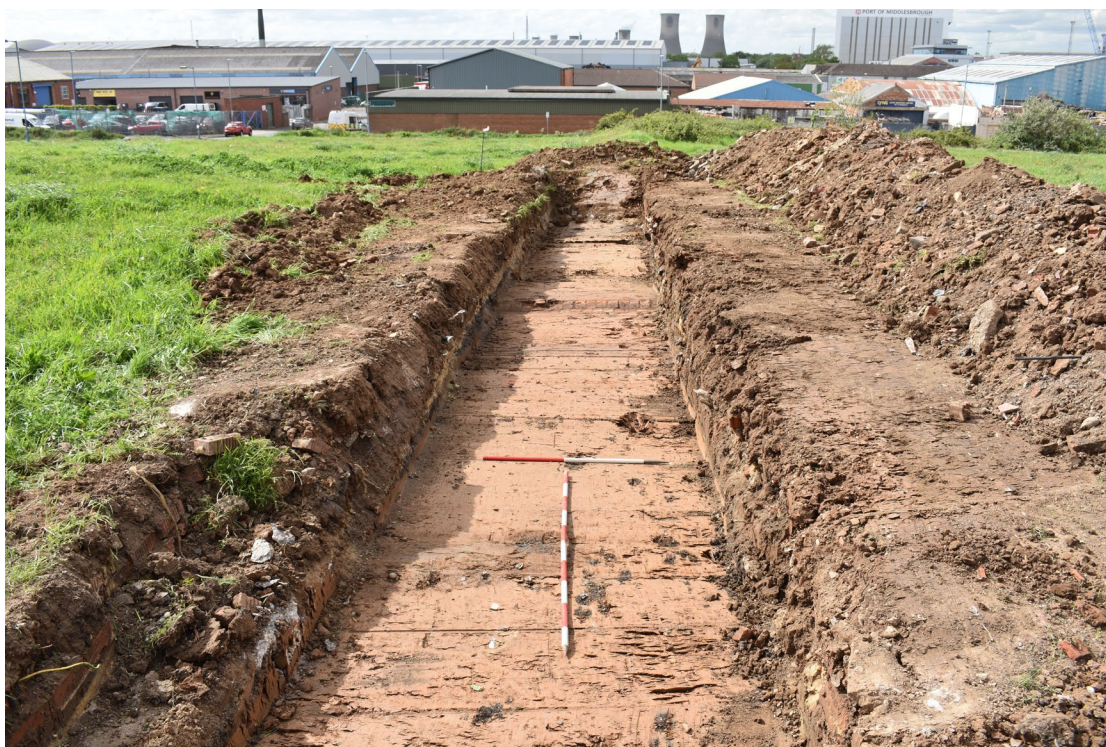
*Plate 21: Trench 7 looking north-west, scale: horizontal 1m, vertical 2m*

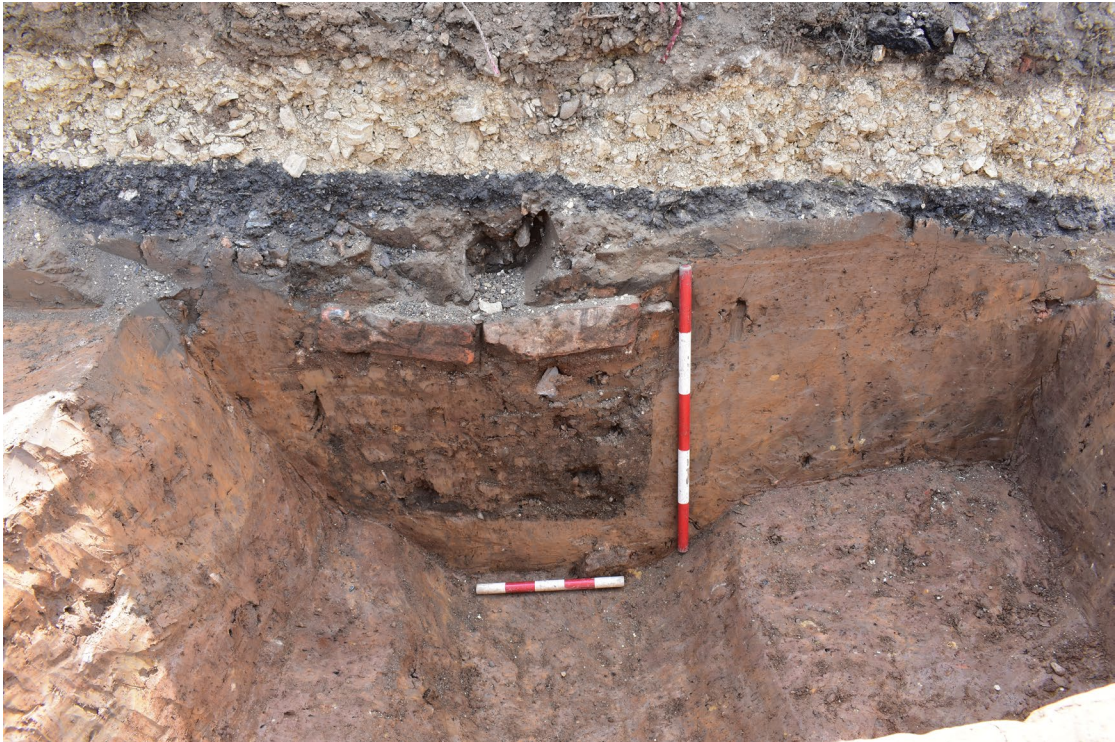
*Plate 22: North-east-facing section through ditch [711] and later drainage features [706]/[708]/[709]/[710] looking south-west, scale: vertical 1m*

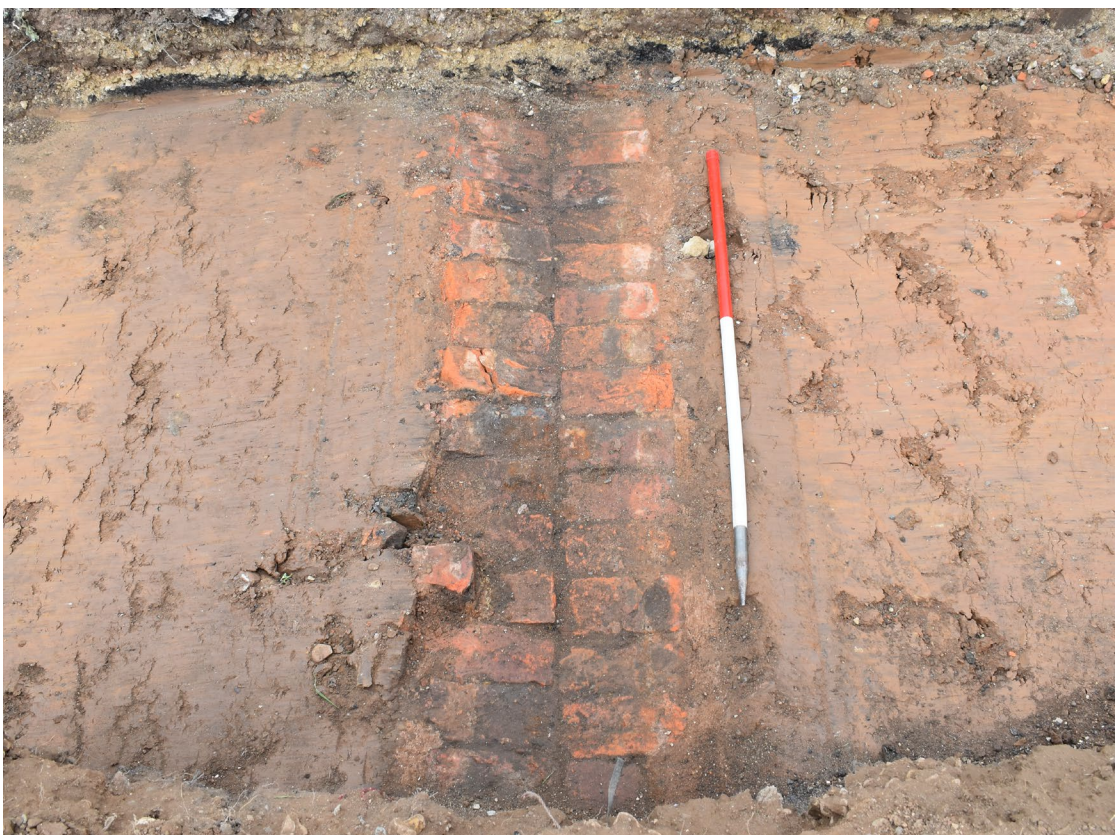
- 7.7.5 Cutting the upper fill [712] of the ditch [711] was a construction cut [708] for a brick drain [709] (Plate 23). The linear construction cut [708] was aligned northeast/southwest and had a vertical profile with curved edges at the break of slope curving into a flat base. The construction cut [708], which measured 0.75m x 0.5m x 0.28m at its exposed limits, was recorded at a height of 8.98m AOD at its base and was cut from a maximum level of 9.28m AOD. The brick drain [709] was aligned northwest/southeast and was constructed using handmade bricks measuring 240mm x 120mm x 80mm with no surviving mortar visible. The drain [709] continued into the southwest facing section of the sondage however was not visible in the northeast facing section, although the construction cut [708] was visible. The construction cut [708] was filled by very stiff mid greyish-brown clayey sand [710] which contained sherds of 19<sup>th</sup> century pottery and clay tobacco pipe (Appendix 2).

*Plate 23: Ditch [711] and drain [706] looking north-east, scale: vertical 1m*

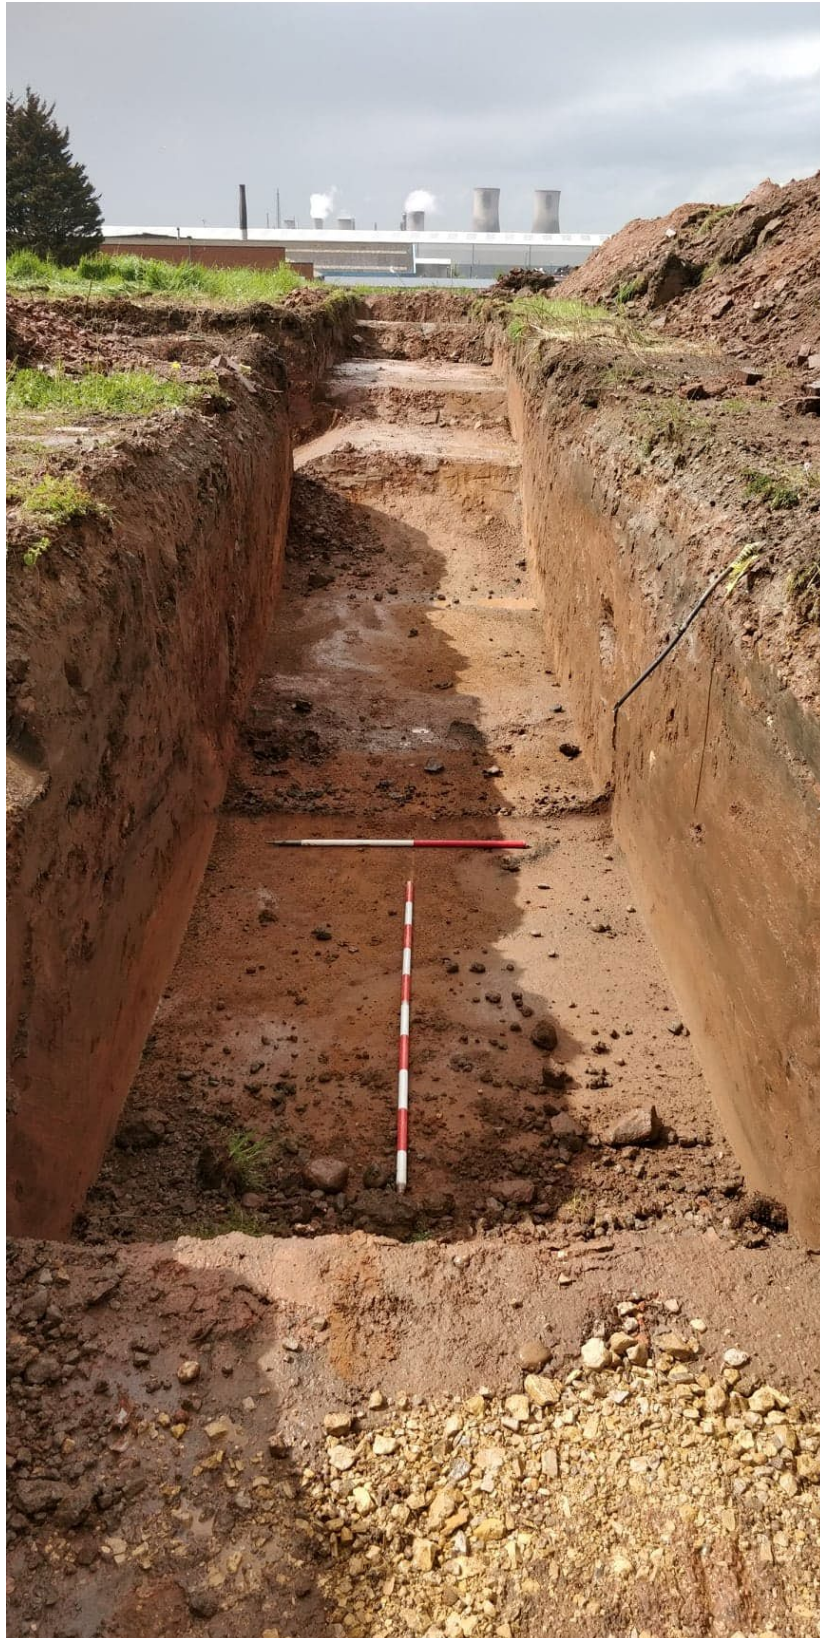
*Plate 24: Trench 8, looking northwest, scale: vertical 2m, horizontal 1m*

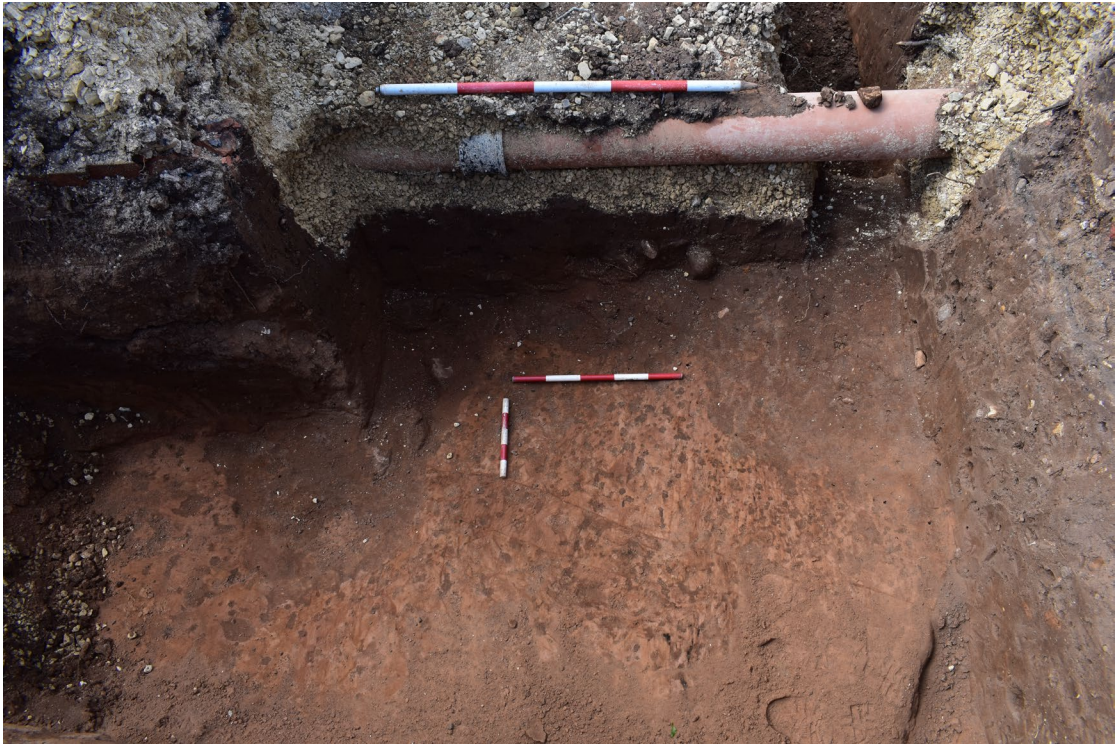
*Plate 25: Pre-excitation shot of pit group [804], [806], [809], [811], [814],[816] and [818] in Trench 8, looking northwest, scale: vertical 0.25m, horizontal 0.50m*

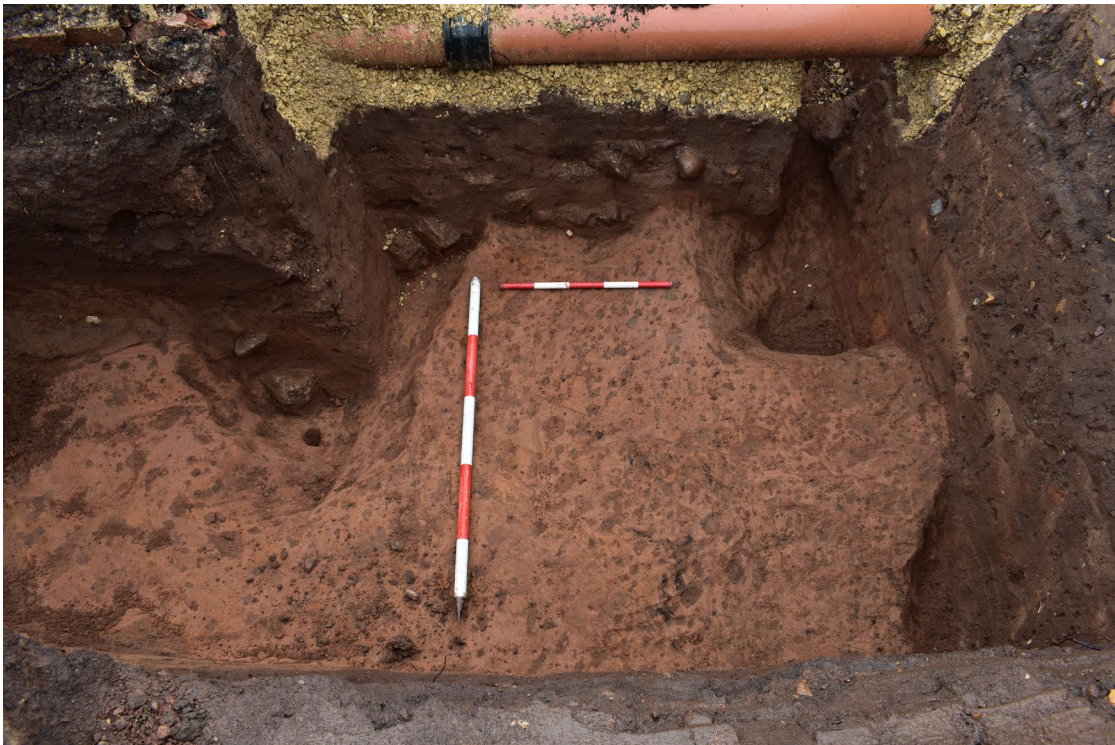
*Plate 26: Post-ex shot of pit group [804], [806], [809], [811], [814],[816] and [818] in Trench 8, looking northwest, scale: vertical 1m, horizontal 0.50m*

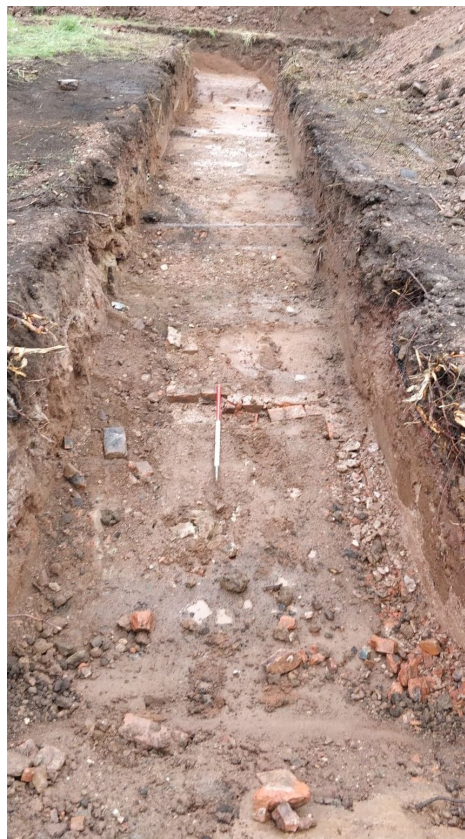
*Plate 27: Trench 9, looking northeast, with wall [901] in the foreground scale: 1m*

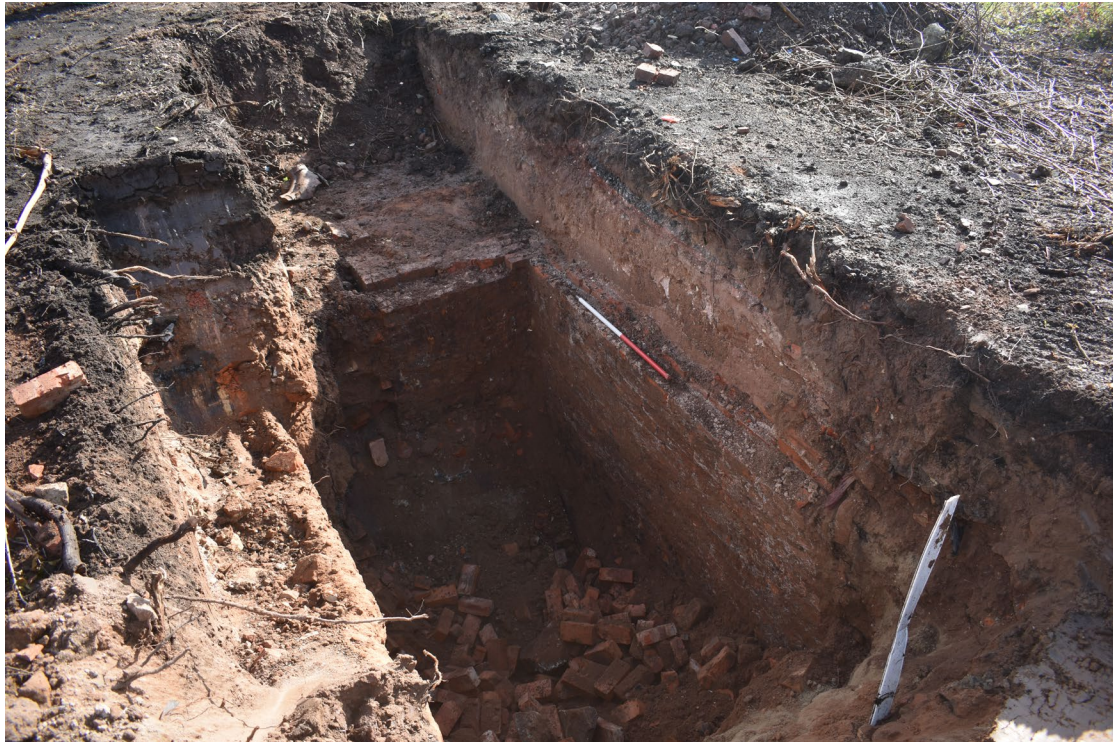
*Plate 28: Trench 9, looking east, showing the fully excavated extent wall [901] scale: 1m*

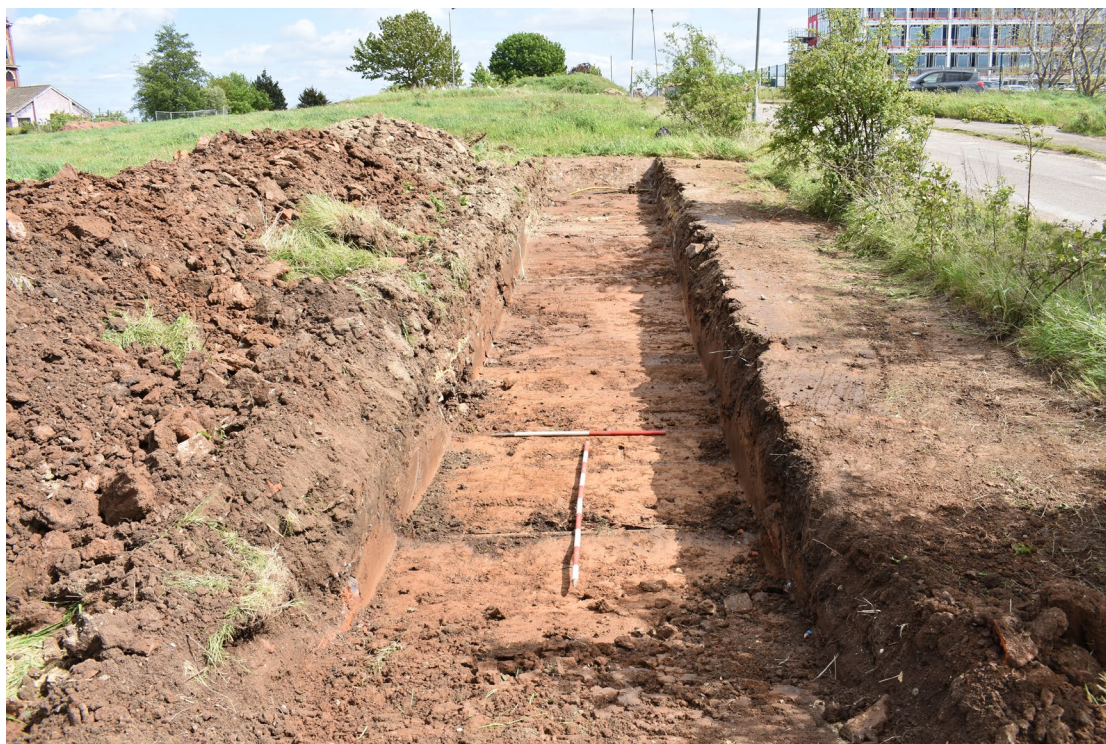
*Plate 30: Trench 11, looking southeast, scale: 1m horizontal, 2m vertical*

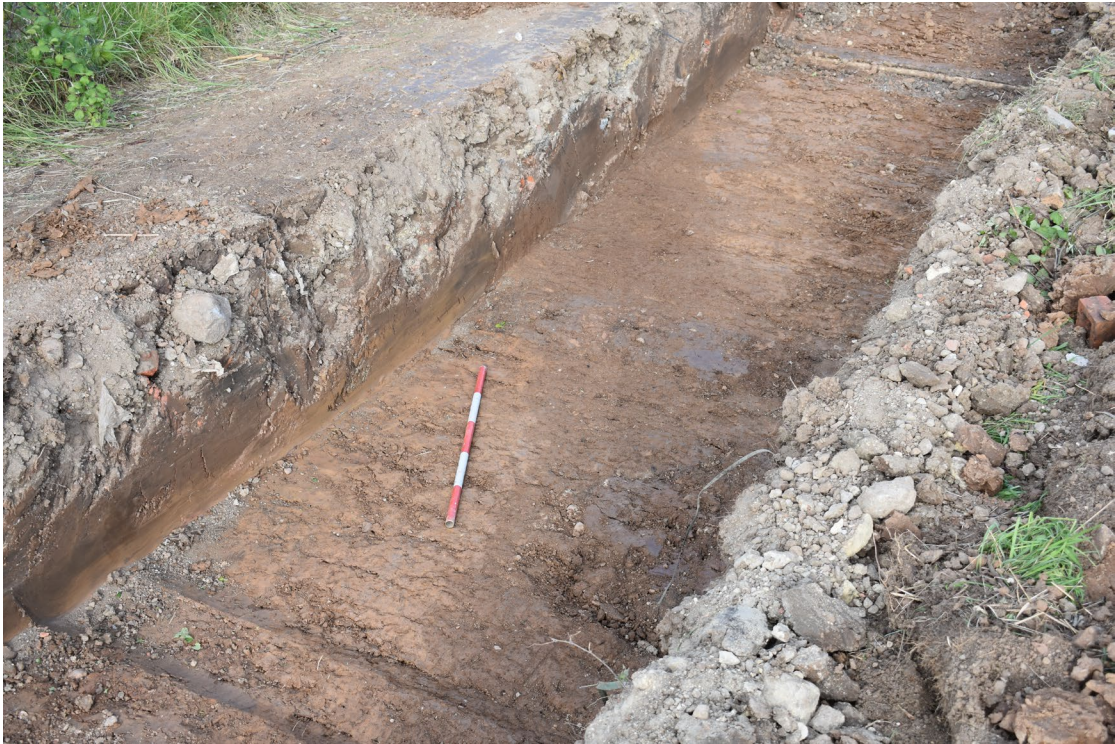
7.11.2 Cutting the natural deposits in the south-western portion of Trench 11 was the cut of a linear ditch [1107] (Plate 31). This ditch [1107] was orientated east/west and was described as having sloping sides with a flat base (Plate 32). The total recorded length was 5.5m with a width of 0.91m and a maximum depth of 0.09m. The ditch [1107], which was recorded at a maximum level of 9.69m AOD, contained a singular fill [1108] which was described as firm mid-brown sandy clay with occasional small sub-angular stones and charcoal flecks. Unfortunately, no dating evidence was encountered but given its stratigraphic position predating later post-medieval activity, it is likely the ditch could represent a boundary marker or agricultural feature associated with the medieval activity in the area.

*Plate 31: Ditch [1107] looking east, scale: 1m vertical*

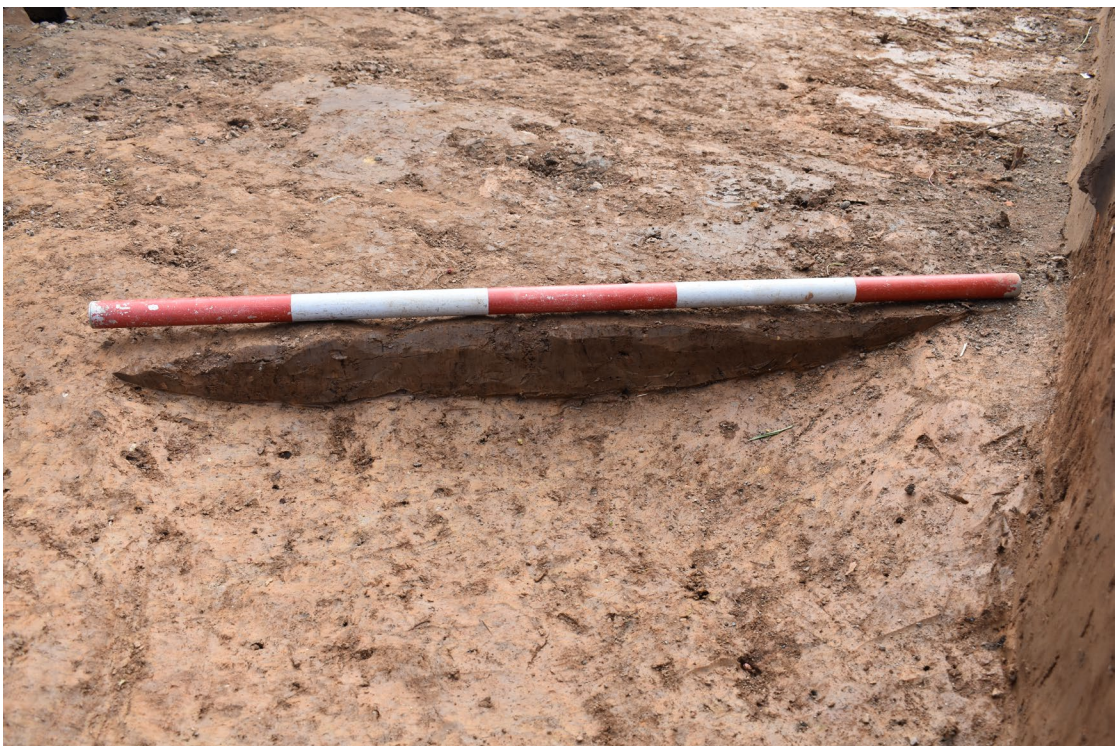
*Plate 32: West-facing section through ditch [1107] scale: 1m horizontal*

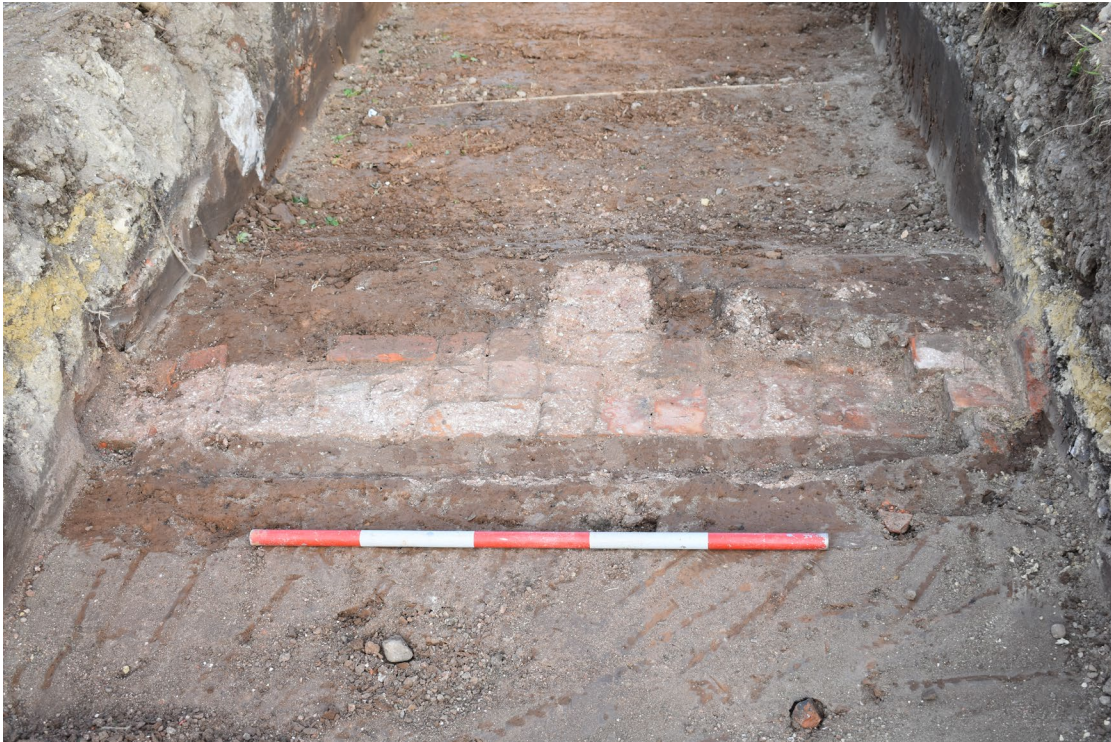
*Plate 33: Wall [1105], looking north-west scale: 1m horizontal*

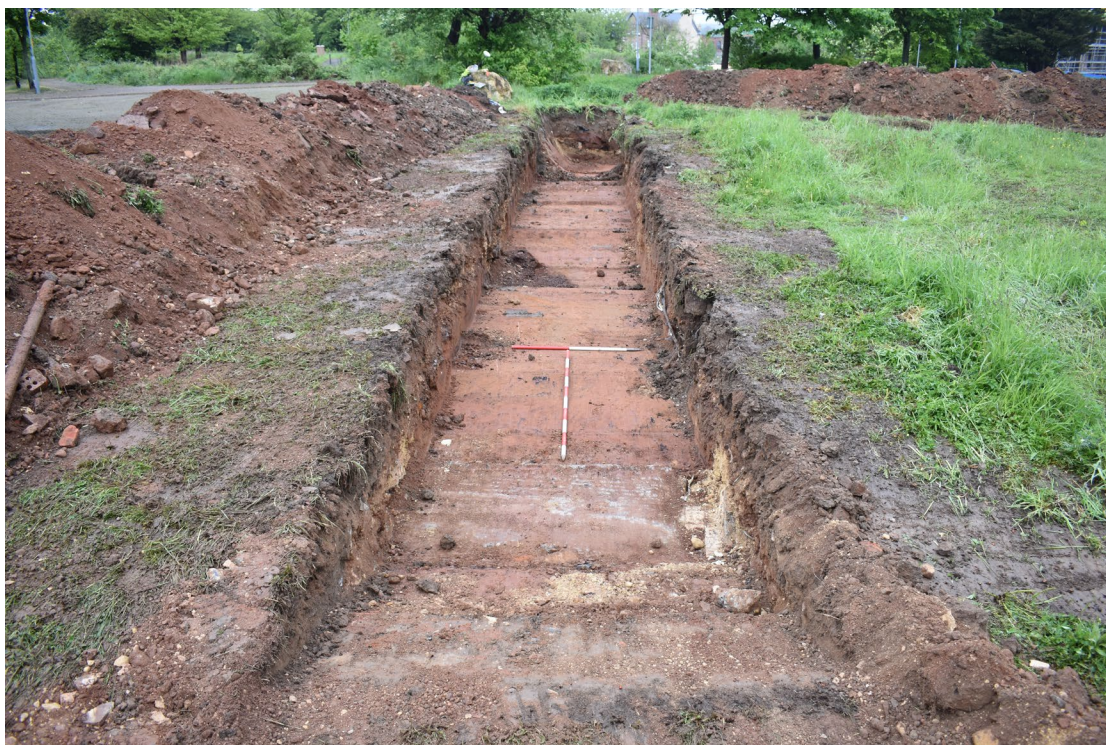
*Plate 34: Trench 12, looking northeast, scale: 1m horizontal, 2m vertical*

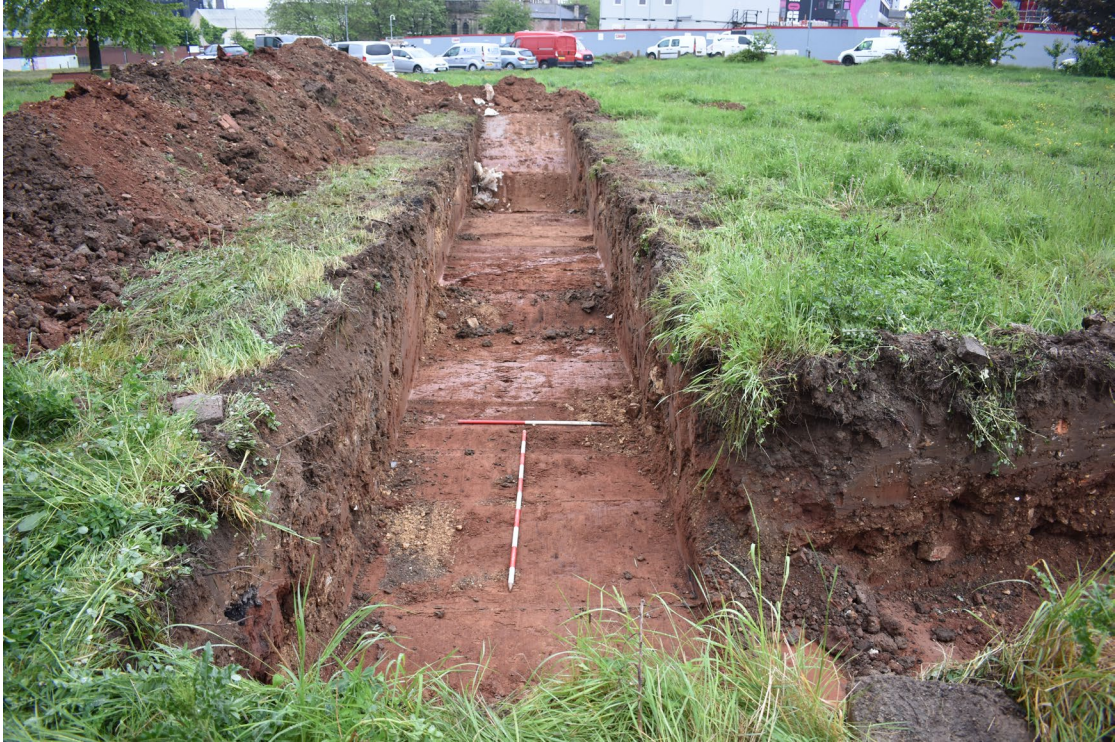
*Plate 35: Trench 13, looking southeast, scale: 1m horizontal, 2m vertical*

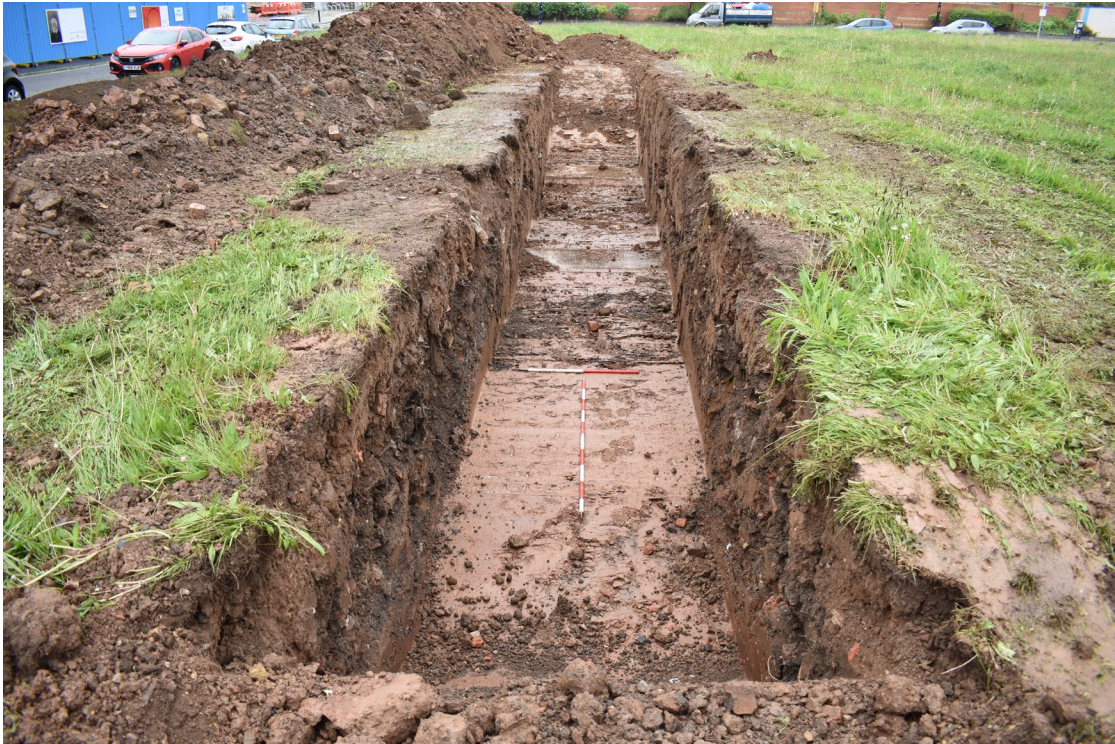
*Plate 36: Trench 14, looking southeast, scale: 1m horizontal, 2m vertical*

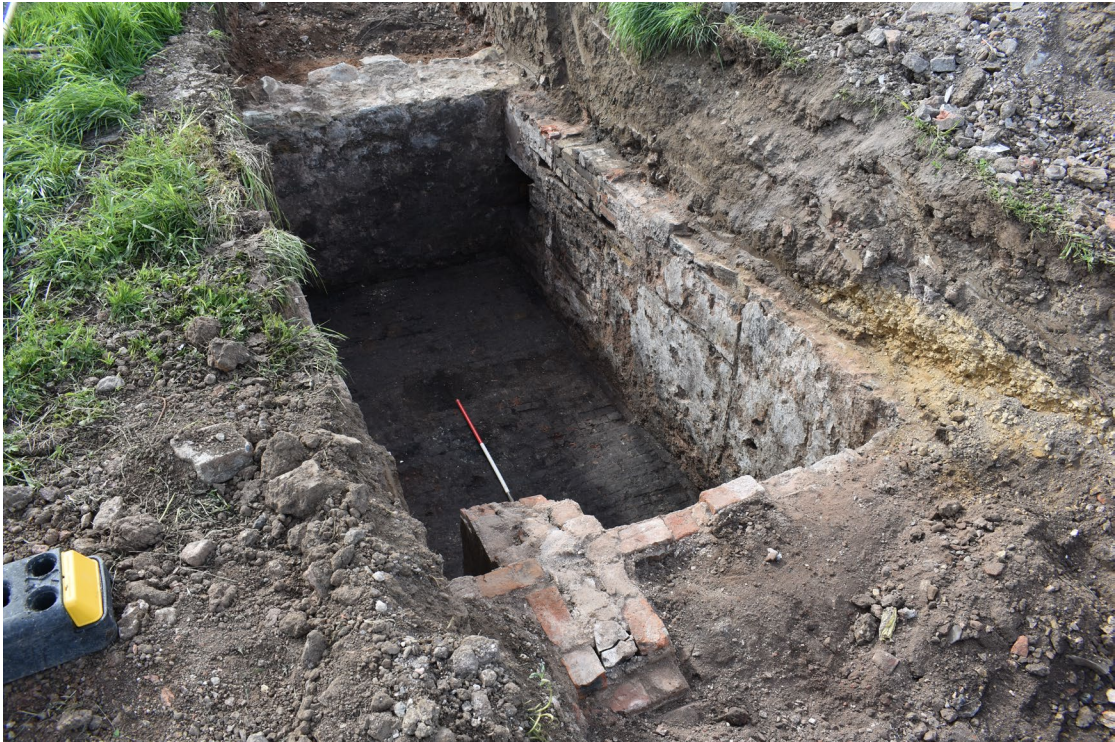
*Plate 37: Trench 15, looking southeast, scale: 1m*

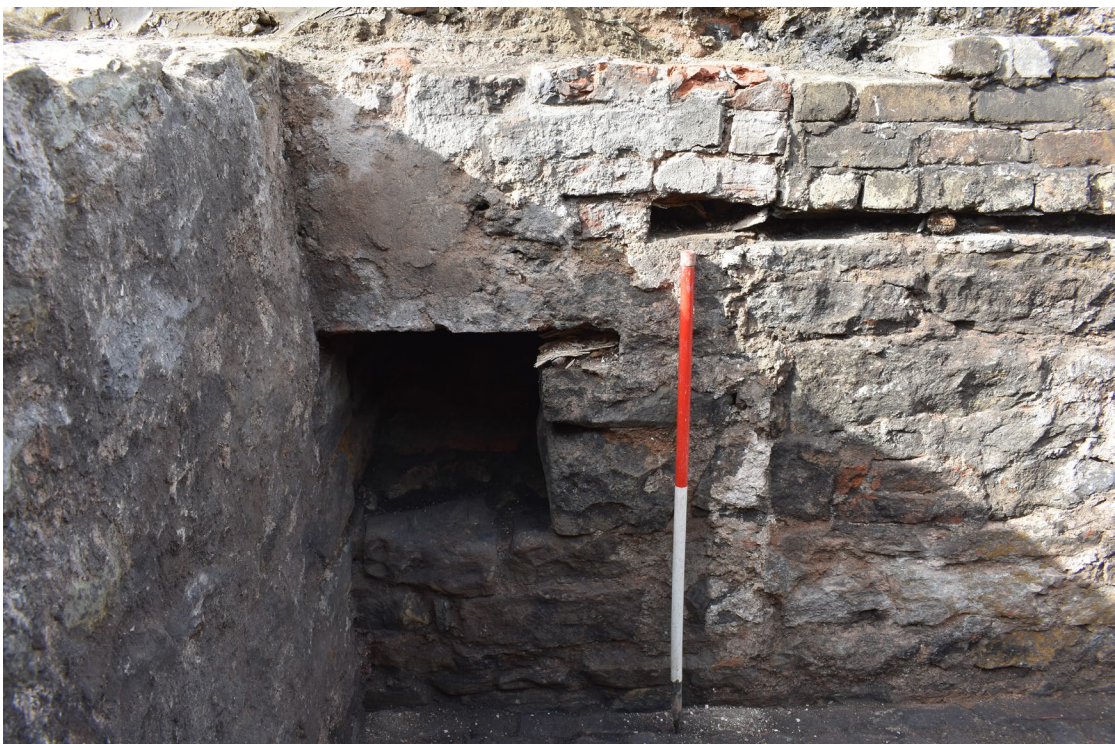
*Plate 38: South-west elevation of cellar with coal chute, looking southwest, scale: 1m*

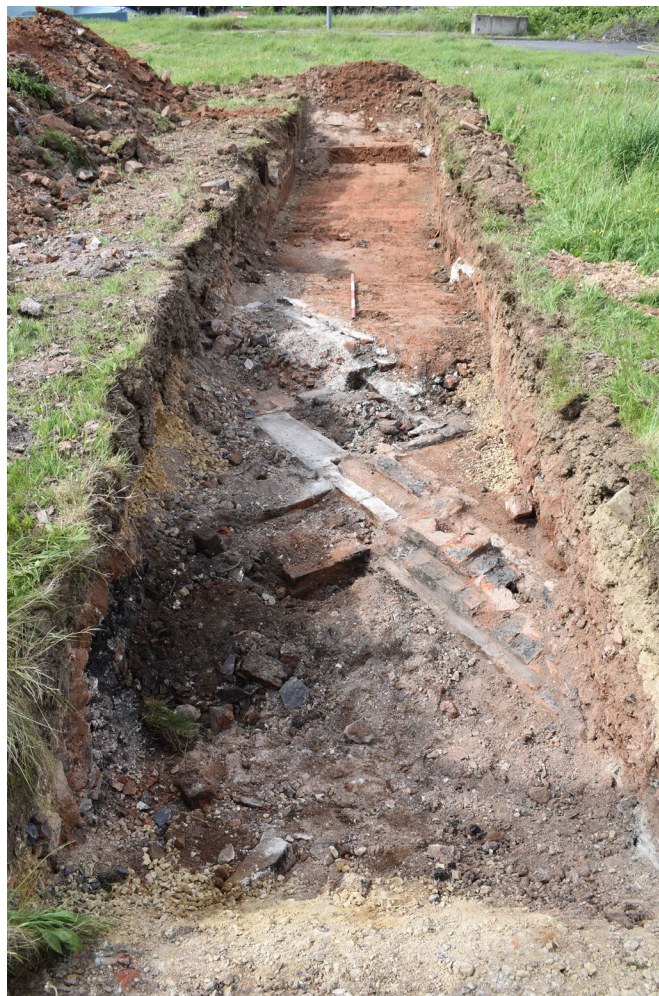
7.16.3 To the south of the brick drain at the southern end of the trench was a brick structure interpreted as the remains of a brick cellar. This brick structure consisted of three masonry elements [1606], [1609] and [1614] which formed in plan the north-west corner of this cellar. this brick structure was consistently described as being constructed out of red hand-made bricks with a hard lime mortar. With overall dimensions of approximately 2.5m in length by approximately 1.5m wide with a recorded level of between 9.64m AOD and 9.7m AOD.

*Plate 39: Trench 16, looking northwest, scale: 1m*
