**Archaeological Evaluation  
Phase 2 Report**

**Former St Hilda's Church  
and Graveyard,  
Middlesbrough, North  
Yorkshire**

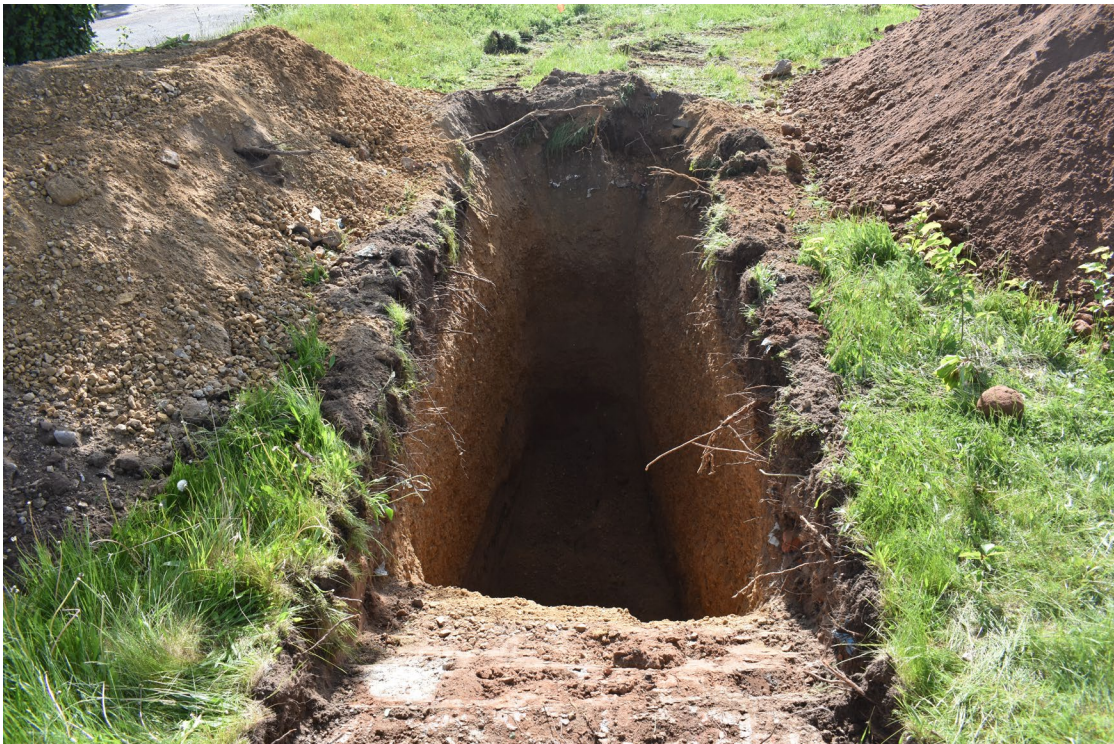
*Plate 40: Trench 17, looking east*

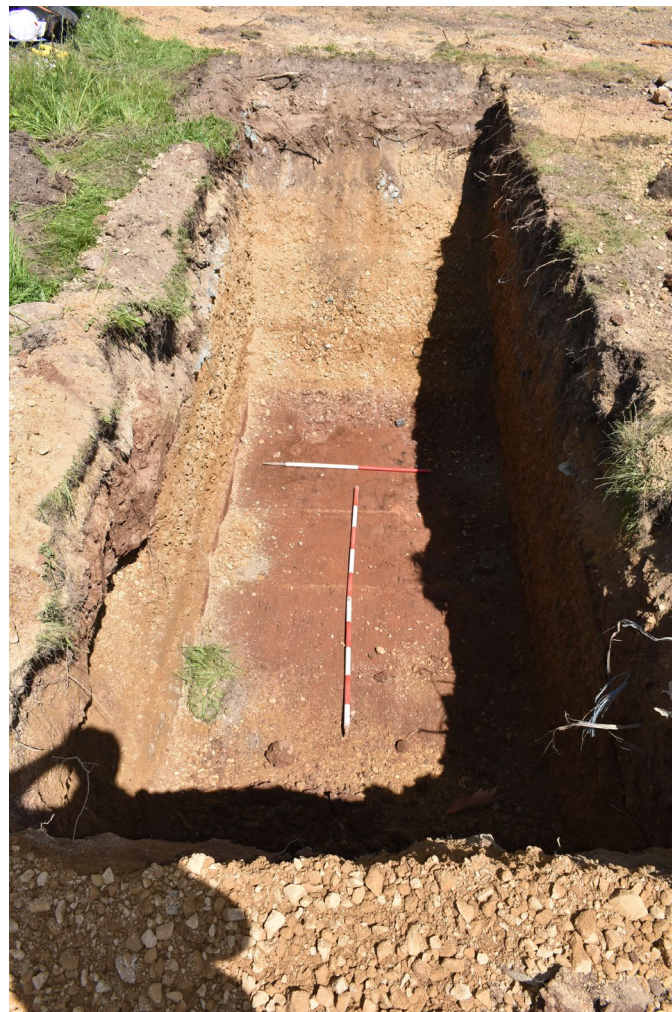
*Plate 41: Trench 17, looking north, scale: 1m horizontal, 2m vertical*

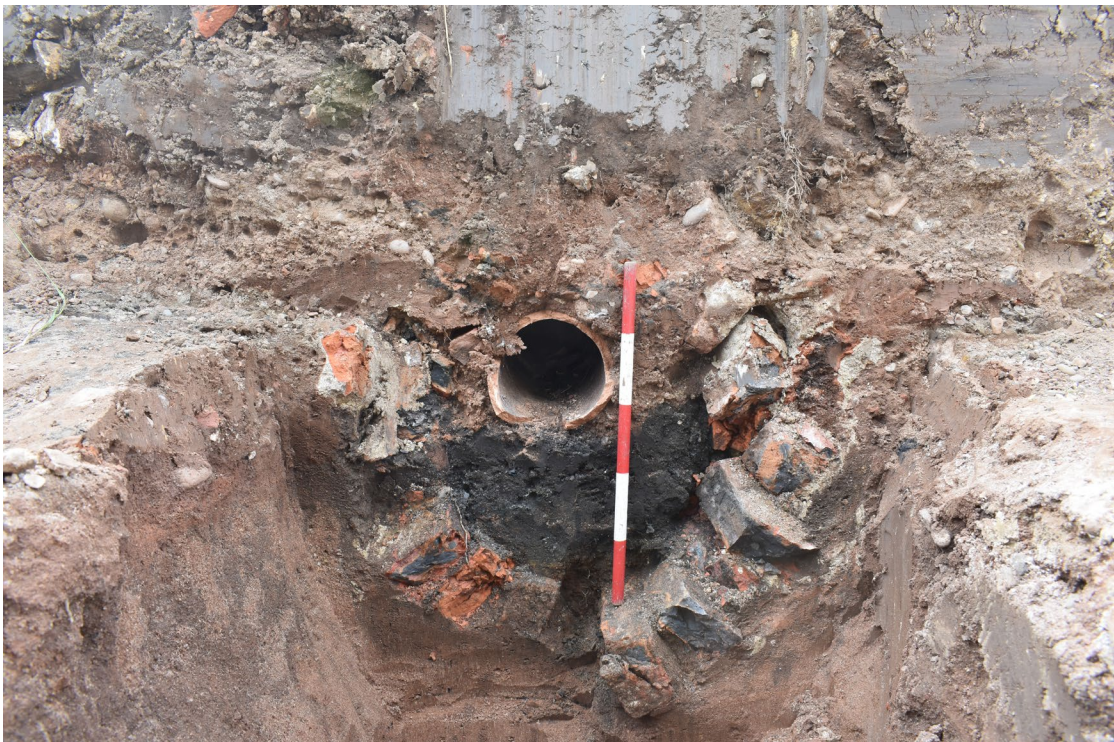
*Plate 42: East-facing section through drain [1905], looking west, scale: 0.50m vertical*

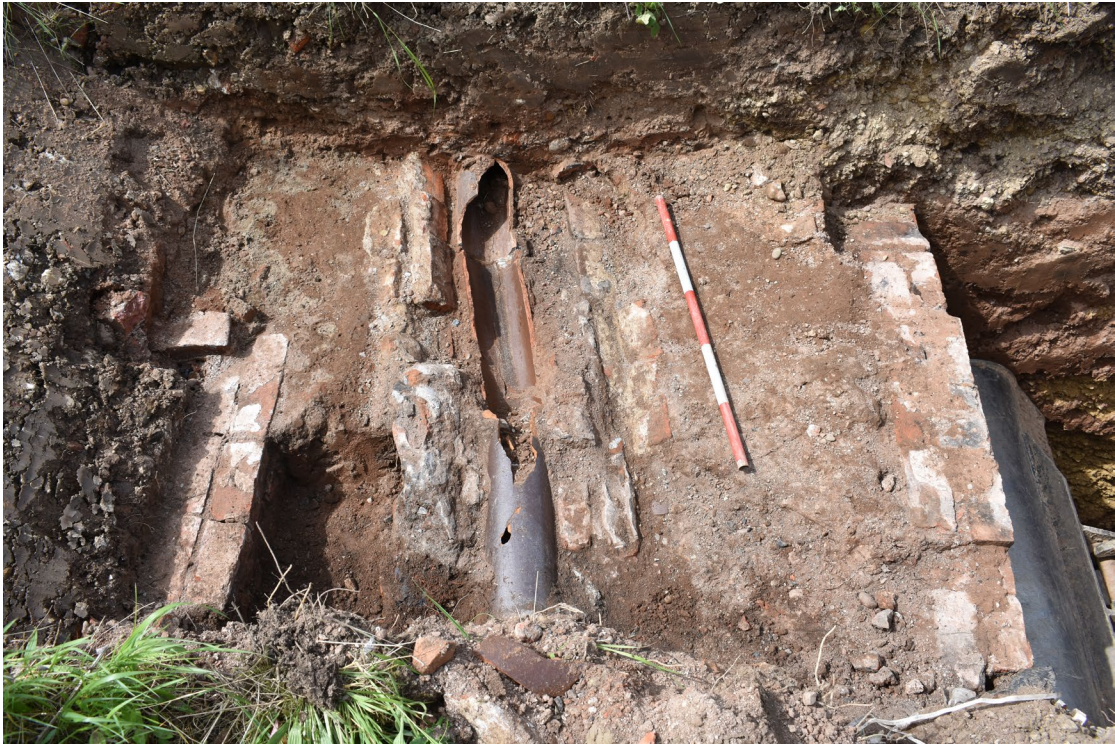
*Plate 43: Structural remains [1910]/[1911]/[1905] in Trench 19, looking west, scale: 1m*

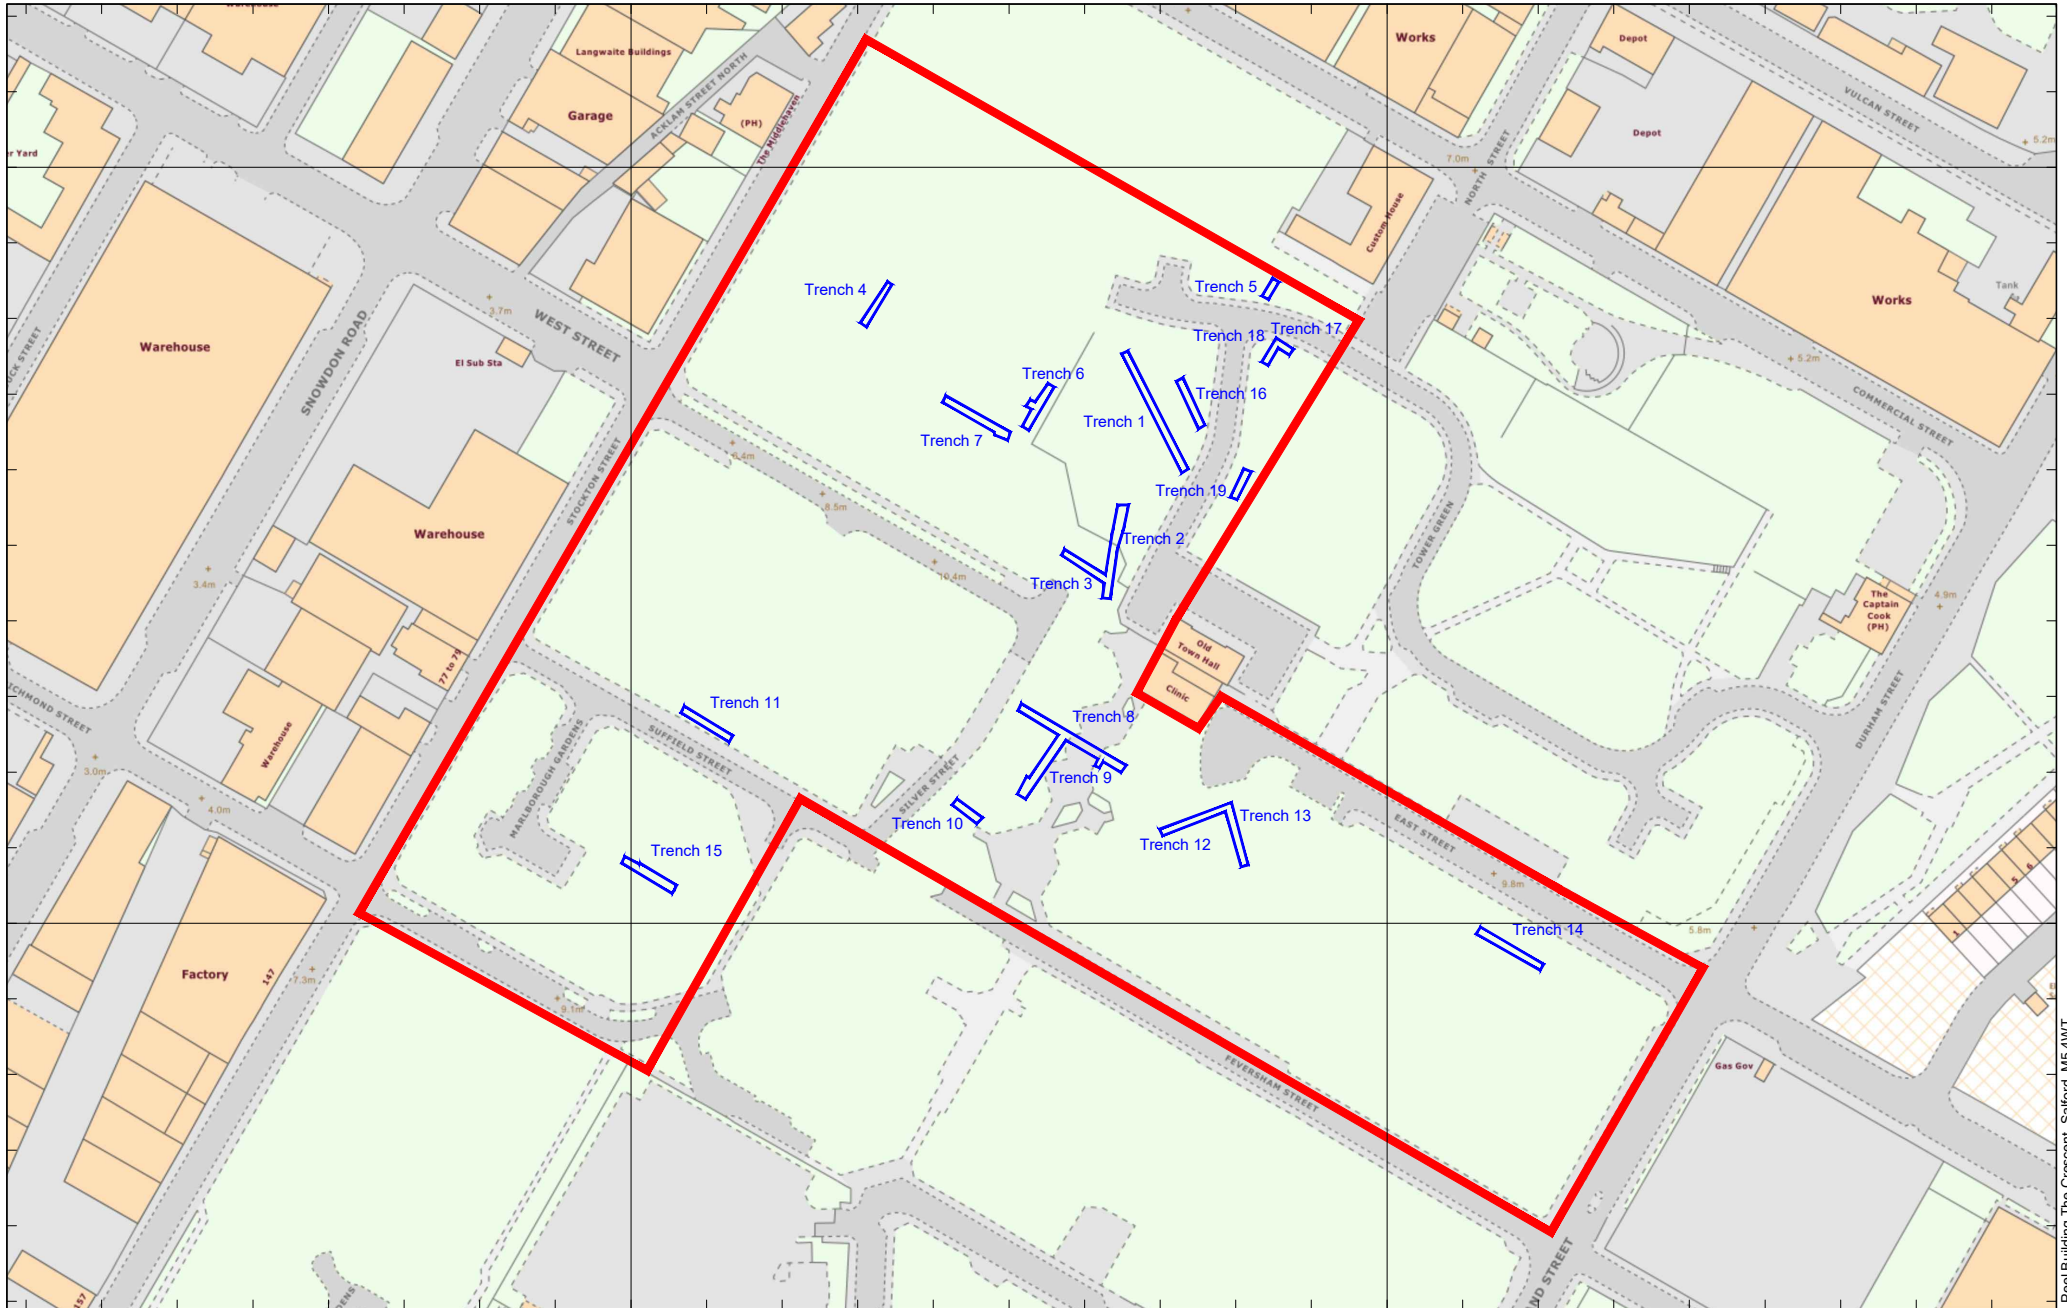
Figure 2:  
Trench Location  
Contains Ordnance Survey data © Crown copyright and database right 2022

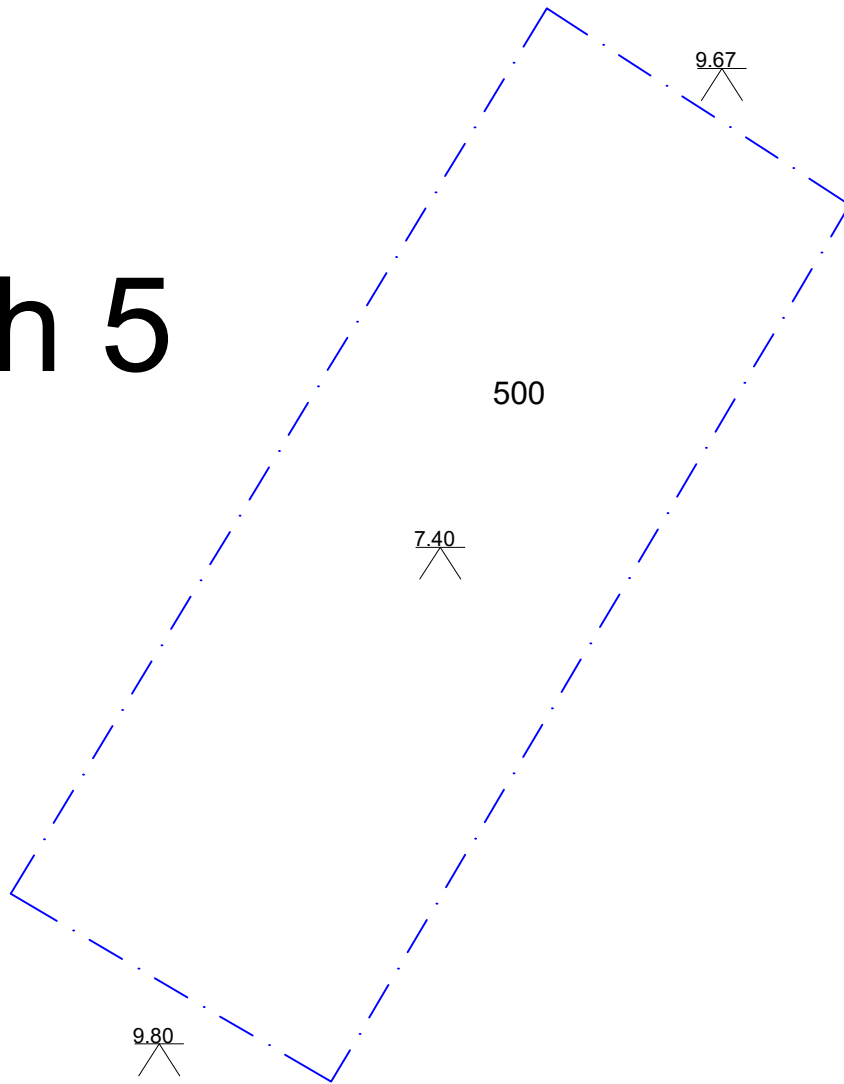
Figure 6:  
Plan of Trench 5

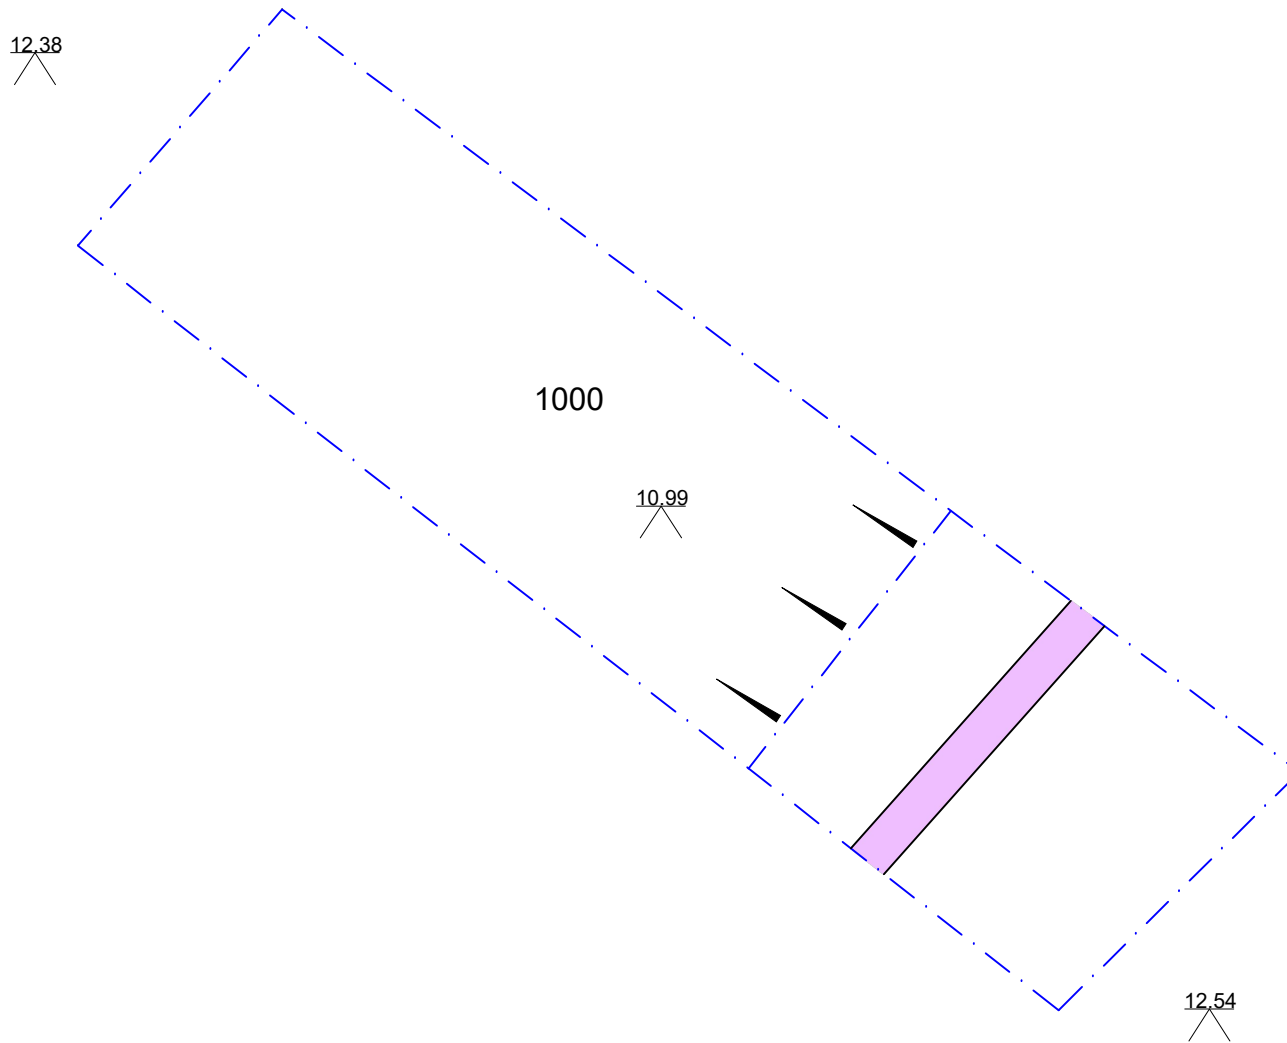
Figure 10:  
Plan of Trench 10

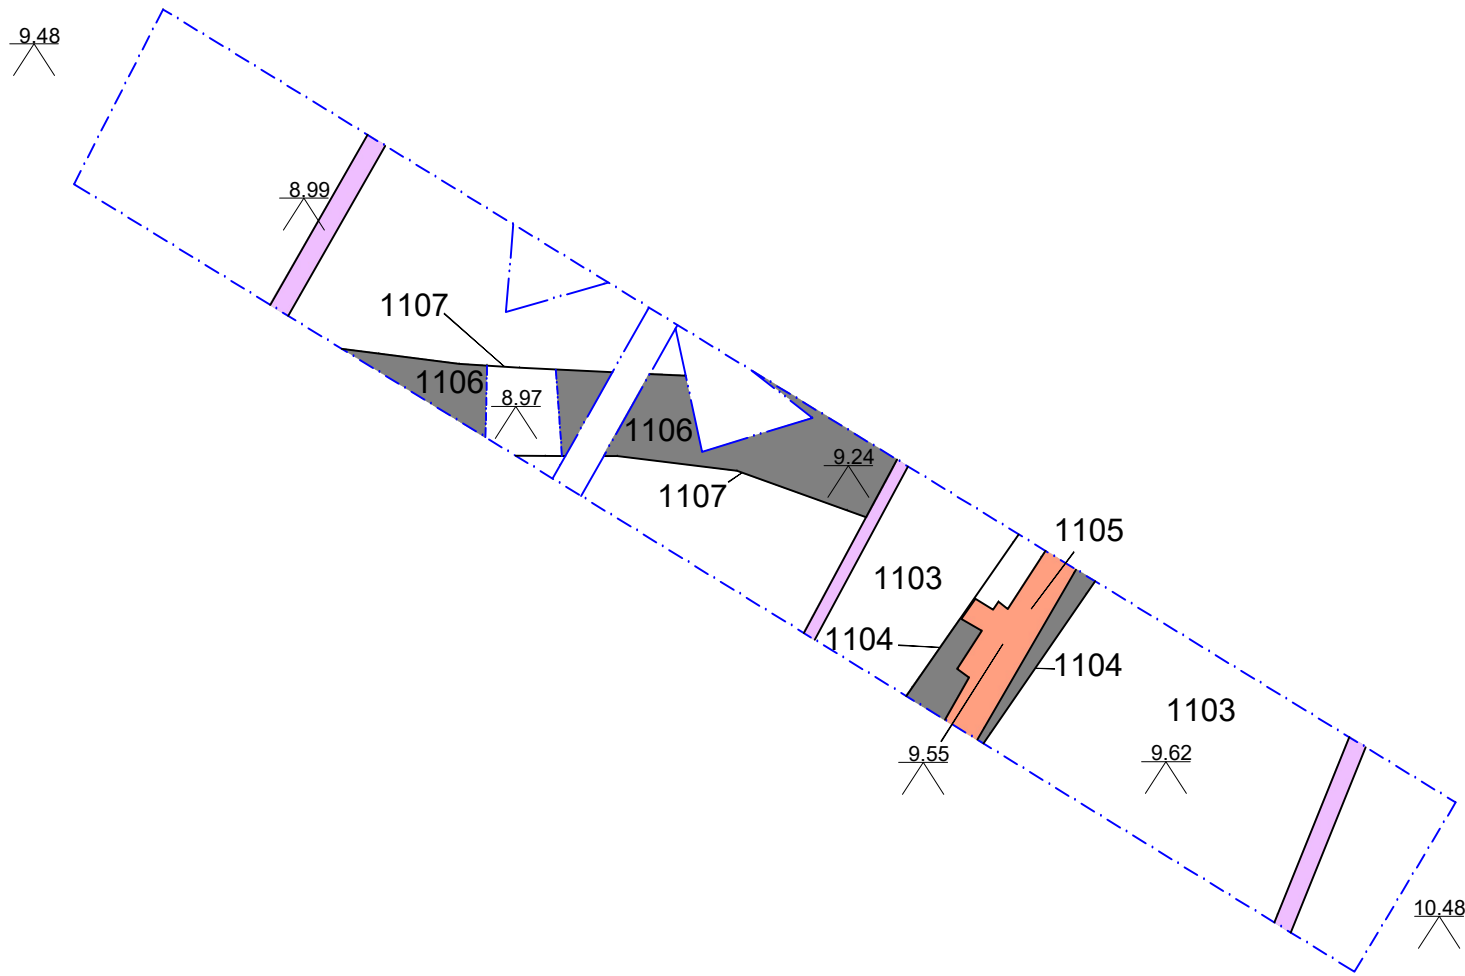
Figure 11:  
Plan of Trench 11
